RESTROOM FEASIBILITY STUDY

STEAM PUMP RANCH

DECEMBER 23, 2011

OPTION 1 PROJECT SCOPE
RENOVATION OF SOUTH BUNK HOUSE

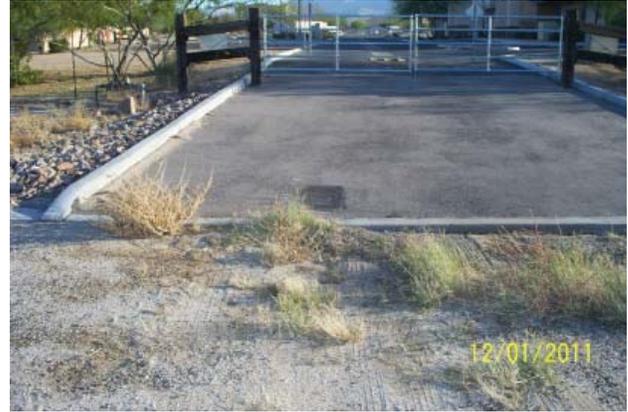
Water connection on north property line.

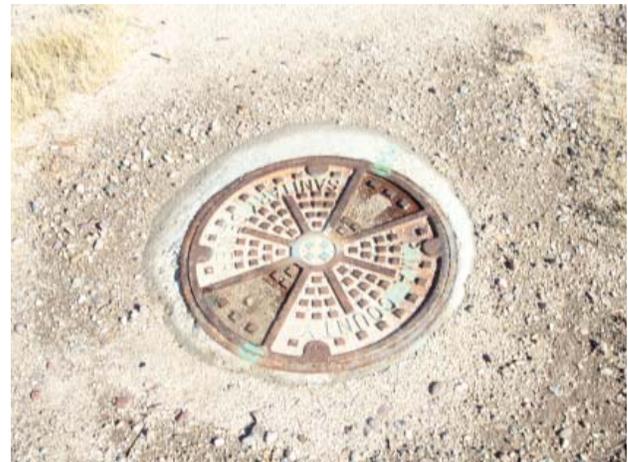
Existing sewer along west property line.

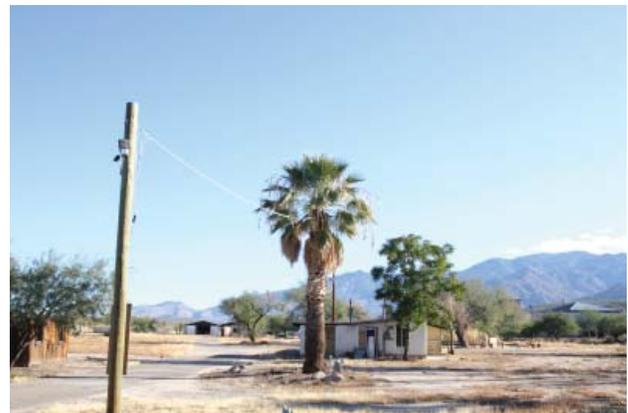
Existing power pole for electrical connection.

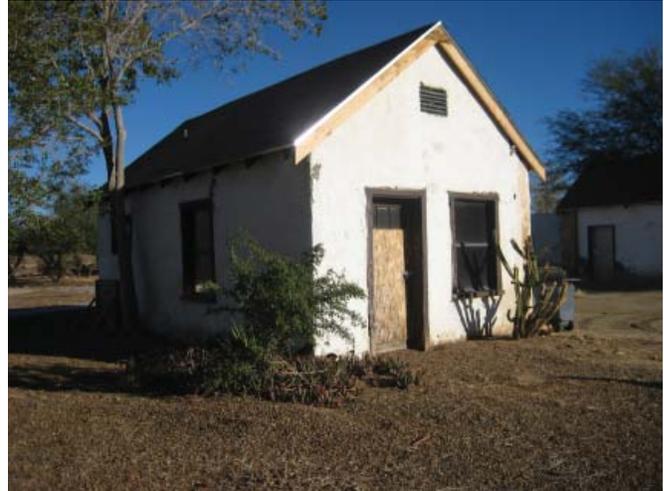
The existing bunkhouse is a 350 sq. ft. mud adobe structure, and is currently unoccupied. The exterior adobe walls are deteriorated and in poor condition, the exterior windows and entry door frames are damaged by termites.

South bunk house looking west.

This option is proposing to renovate the existing structure to allocate two single user toilets. The exterior walls need to be renovated by removing the existing stucco finish, restore and stabilize the adobe walls with blocks fabricated on site, and refinish the exterior surfaces with cement stucco. The existing fenestrations will be treated with new windows and the existing door will be replaced. A couple of new doors will be installed to provide access to the proposed restrooms. A new porch will be added, consisting of an attached wood framed structure to the north of the building with a steel deck roof covering. Also an exterior concrete slab at the storage and restroom entries will be provided for accessibility.

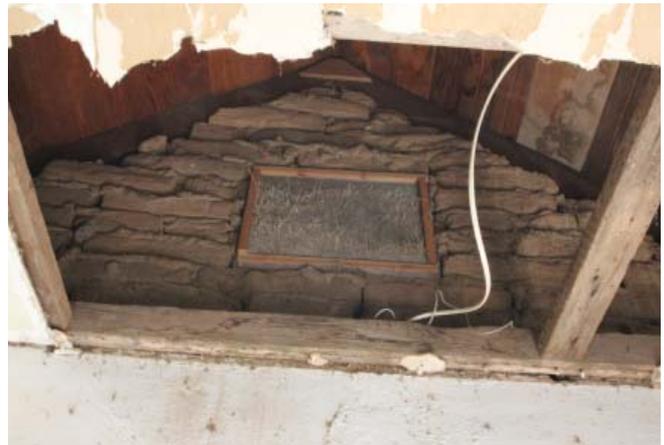
The existing roof structure is in good condition, and it appears that a new roofing has been installed recently.

Bunk house condition above ceiling.

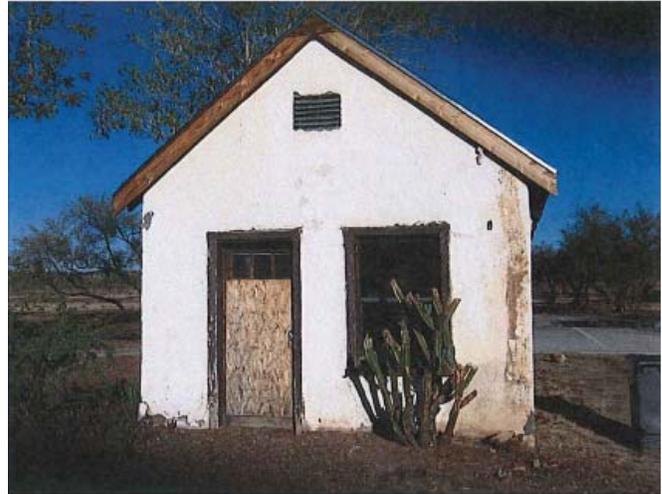
East elevation

1. The mud adobe walls are in relatively poor condition with some regions, all near the grade level, where the adobe blocks have disintegrated. It is noted, and expected for a building of this age, that the walls all have some degree of tilt and they are slightly out-of plumb
2. Headers for adobe wall openings were noted to be of wood which was common at the time of construction. The structural wood lintels which were visible appeared to be in acceptable condition while the mullions/bucks for the existing windows were eaten by termites.
3. The wood roof framing appeared to be in acceptable condition with the rafter's consisting of rough sawn 2x6's and the ceiling cross ties either as 2x4 nominal cross ties or rough sawn 2x6's.

1. Repair the exterior adobe walls by replacing deteriorated adobe areas. Repoint and/or reapply adobe mortar where mortar has deteriorated. This work should be performed by an adobe restoration expert. Stabilize the adobe and replaster as required to seal the adobe from water damage.
2. Remove exterior trees that are within 5' of the exterior envelope. If this is not performed then root upheaval causing wall damage will continue.
3. Remove and replace the entire interior concrete slab. Provide a 4" aggregate base course; hand compacted, below a new 4" thick concrete slab reinforced with 4 lbs/ cubic yard of macrofibers.

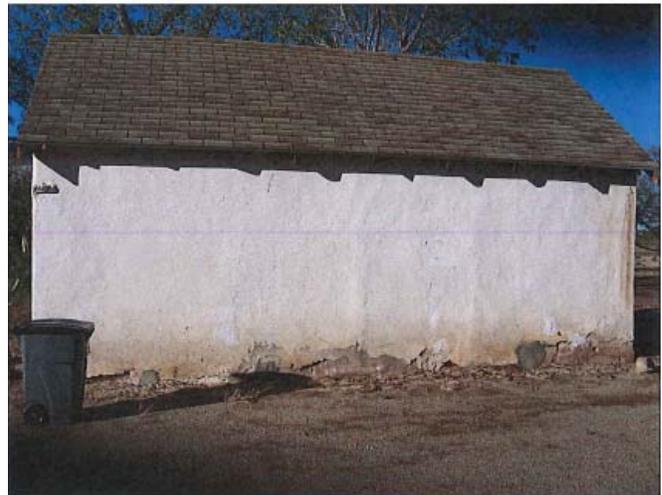
North elevation

4. The floor slabs are in poor conditions, completely cracked up, and are differentially settling.
5. There are trees planted within a foot of these building walls which appear to be causing some movement and/or upheaval to the walls.

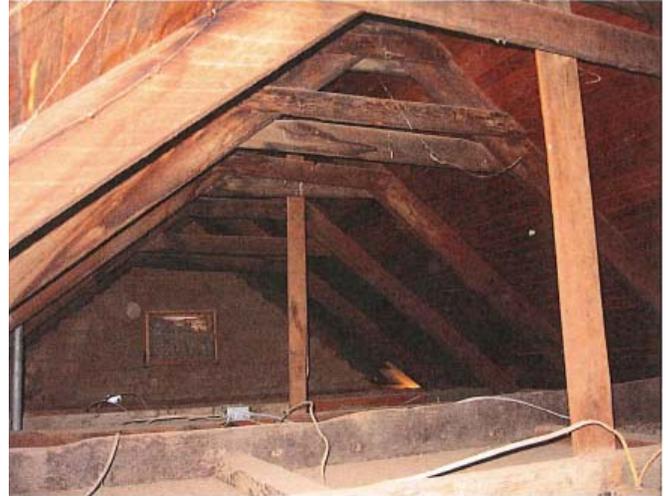
Interior rafter view.;

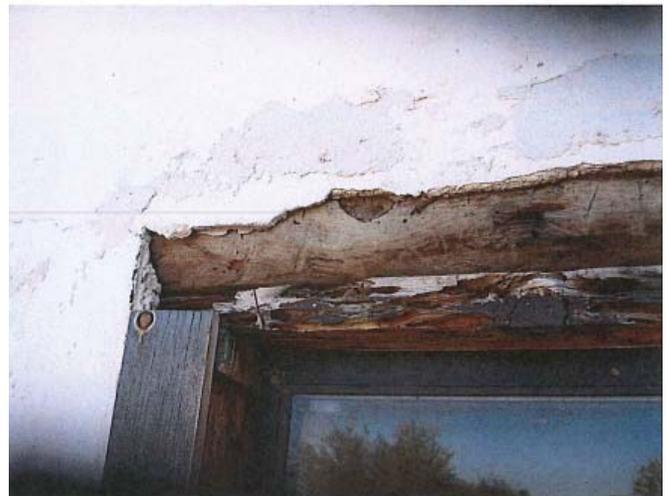
Existing intact wood header with termite damage.
