RESTROOM FEASIBILITY STUDY

STEAM PUMP RANCH

DECEMBER 23, 2011

OPTION 1 PROJECT SCOPE
RENOVATION OF SOUTH BUNK HOUSE

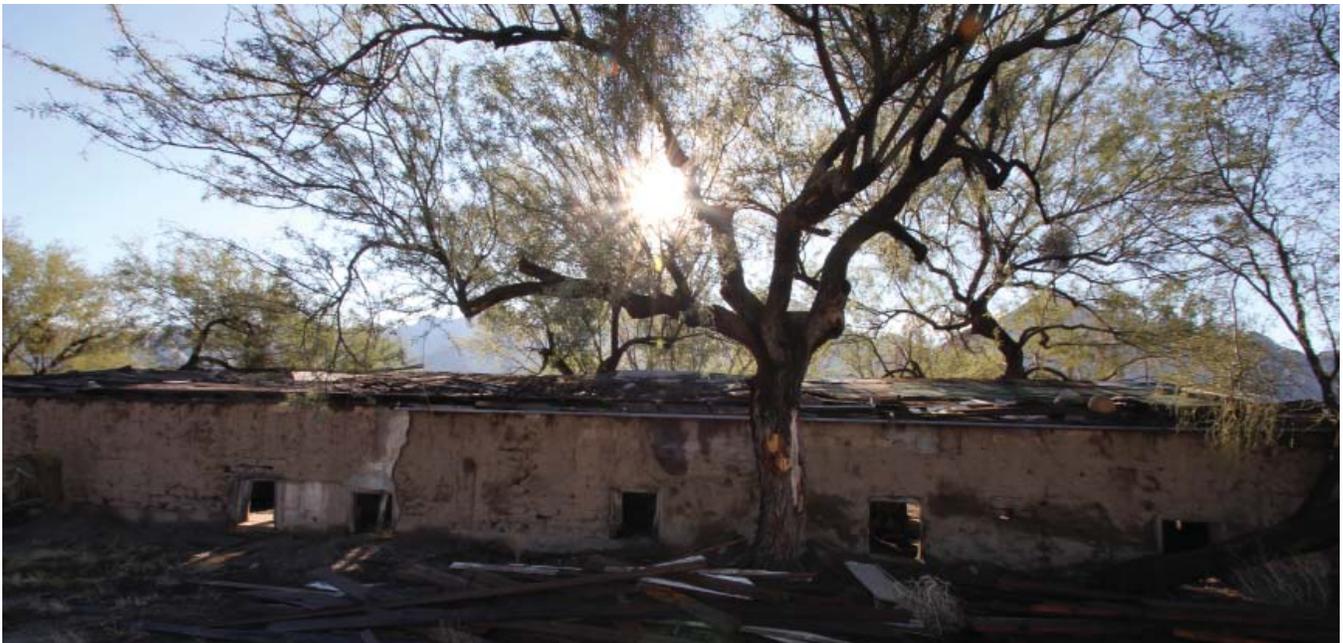
View of chicken coop looking east.

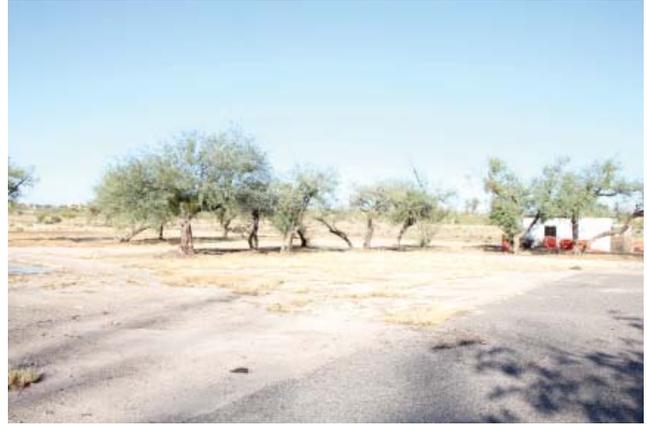
Proposed location of building kit.

A 110 Sq. Ft. prefabricated toilet facility kit is proposed to be installed northwest of the existing pad, just outside the 50 ft. utility easement. The 2 single user toilet kit includes full steel reinforced concrete foundations and meet all ADA accessibility guidelines.
